# **NATIONAL TRANSPORTATION SAFETY BOARD**

## **RAILROAD ACCIDENT REPORT**

**DERAILMENT OF AMTRAK TRAIN 4, SOUTHWEST CHIEF,  
ON THE BURLINGTON NORTHERN SANTA FE RAILWAY  
NEAR KINGMAN, ARIZONA  
AUGUST 9, 1997**

**Notation 6912B  
Adopted August 31, 1998**

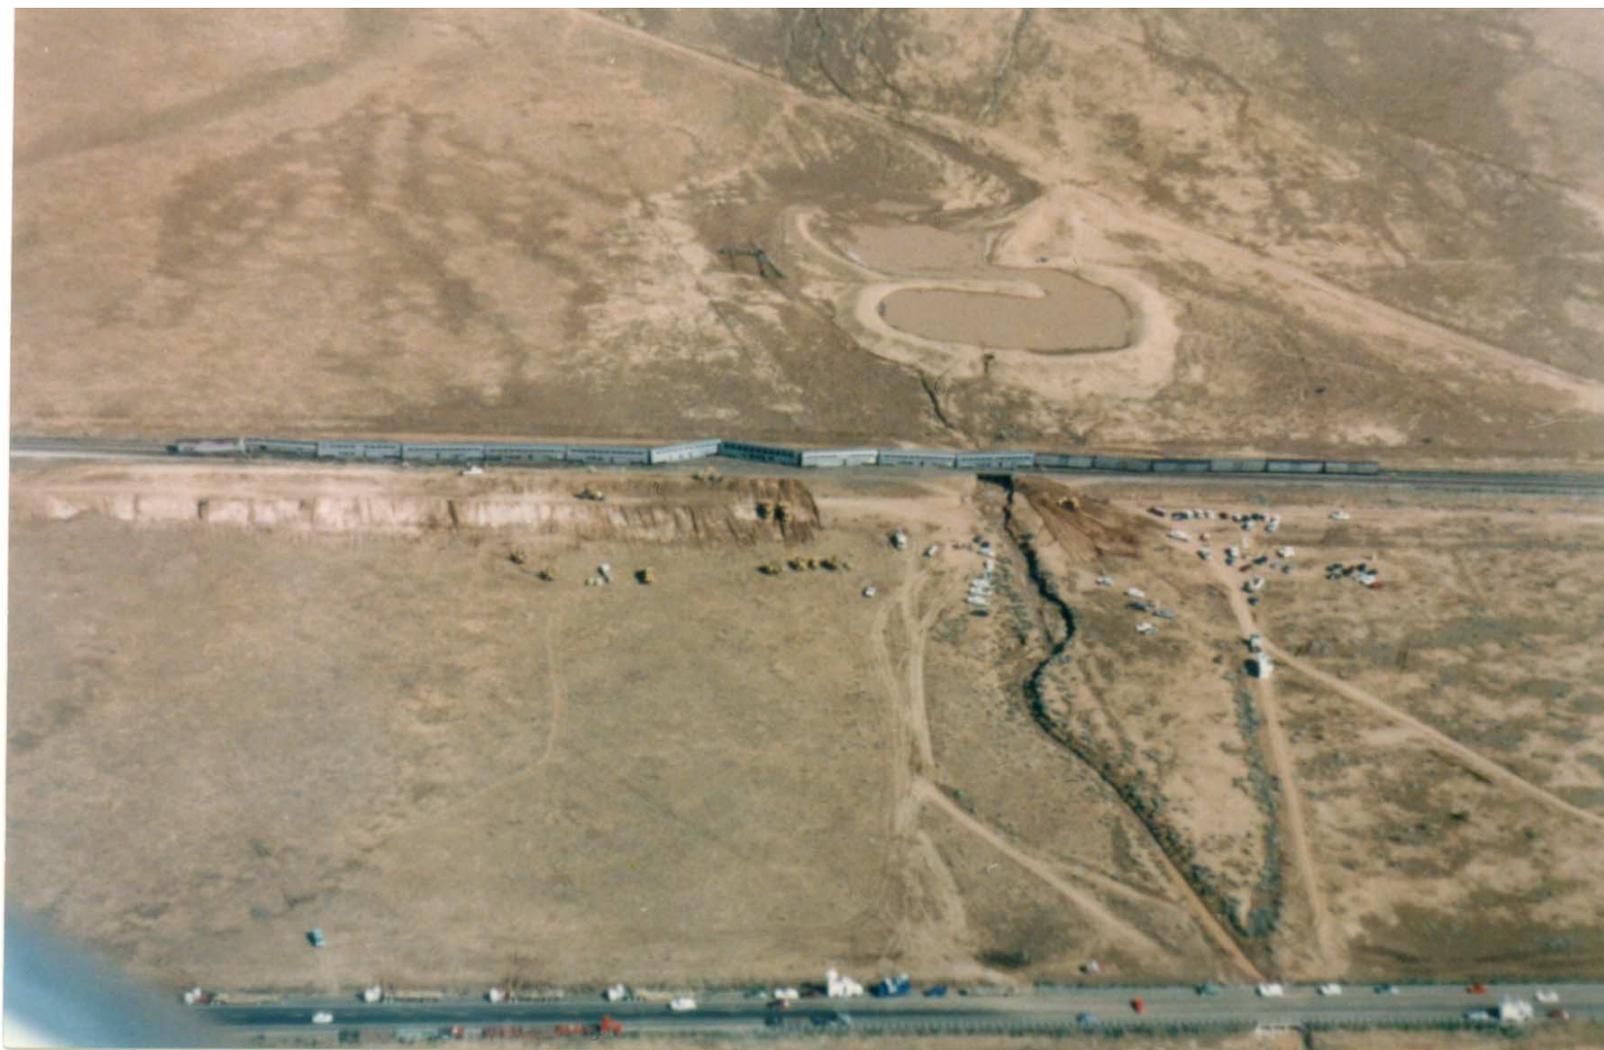
Figure 1. Aerial view of the derailment site, looking south

The third and fourth units, including all but the last car, derailed in the upright position. Although some cars were at a slight angle to each other and leaning, all cars remained coupled and generally aligned with the track. The tenth car, a sleeping car, came to rest spanning what had been the track at the location of bridge 504.1S. (See figure 1 for an aerial view, looking south, of the Kingman accident site. Figures 2 and 3 show, respectively, a map and a schematic of the derailment site.)

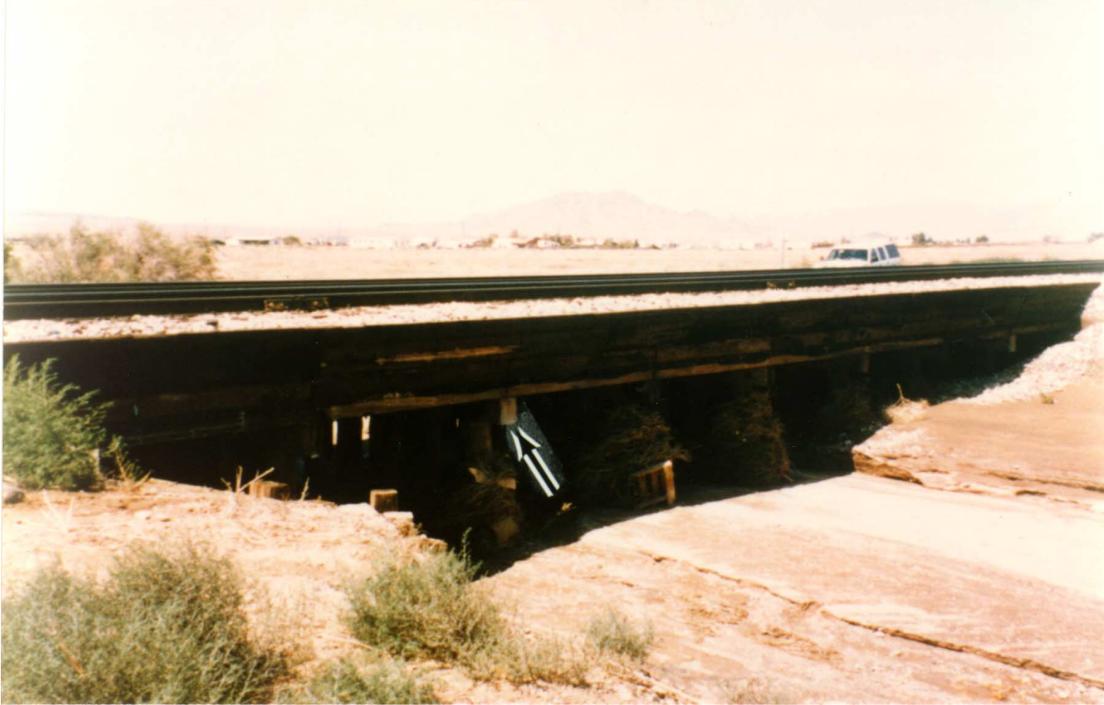
Figure 11. HWD on bridge 505.9

Bridge 504.1, where Amtrak train 4 derailed, had no HWD; however, an HWD was located at bridge 505.9, which was linked to signals 5051 and 5082. (See figure 11, which shows the HWD location.) When the HWD is activated, it causes the signals at 5051 and 5082 to display a RED aspect, which, according to BNSF operating rules, requires the engineer to stop the train and proceed at restricted speed to the next signal. The HWD must then be manually reset before the signals will display any other aspect. The HWD at bridge 505.9 did not activate during the storm preceding the derailment because the flow of water was not high enough to contact the HWD. The HWD is mounted under the south bridge, approximately 18 inches below the bottom of the bridge deck, or about 5 feet above the streambed. (See figure 12 for a closeup view of the HWD.)
